CONE BEAM CT REPORT

CASE -----

Patient Name:	Name, Fake	Referring Doctor:	-
Patient DOB:	January 1, 1970	Scan Date:	July 28, 2015
Reason for Exam:	Evaluate dentition, root canals, implants		
Doctor Notes:	-

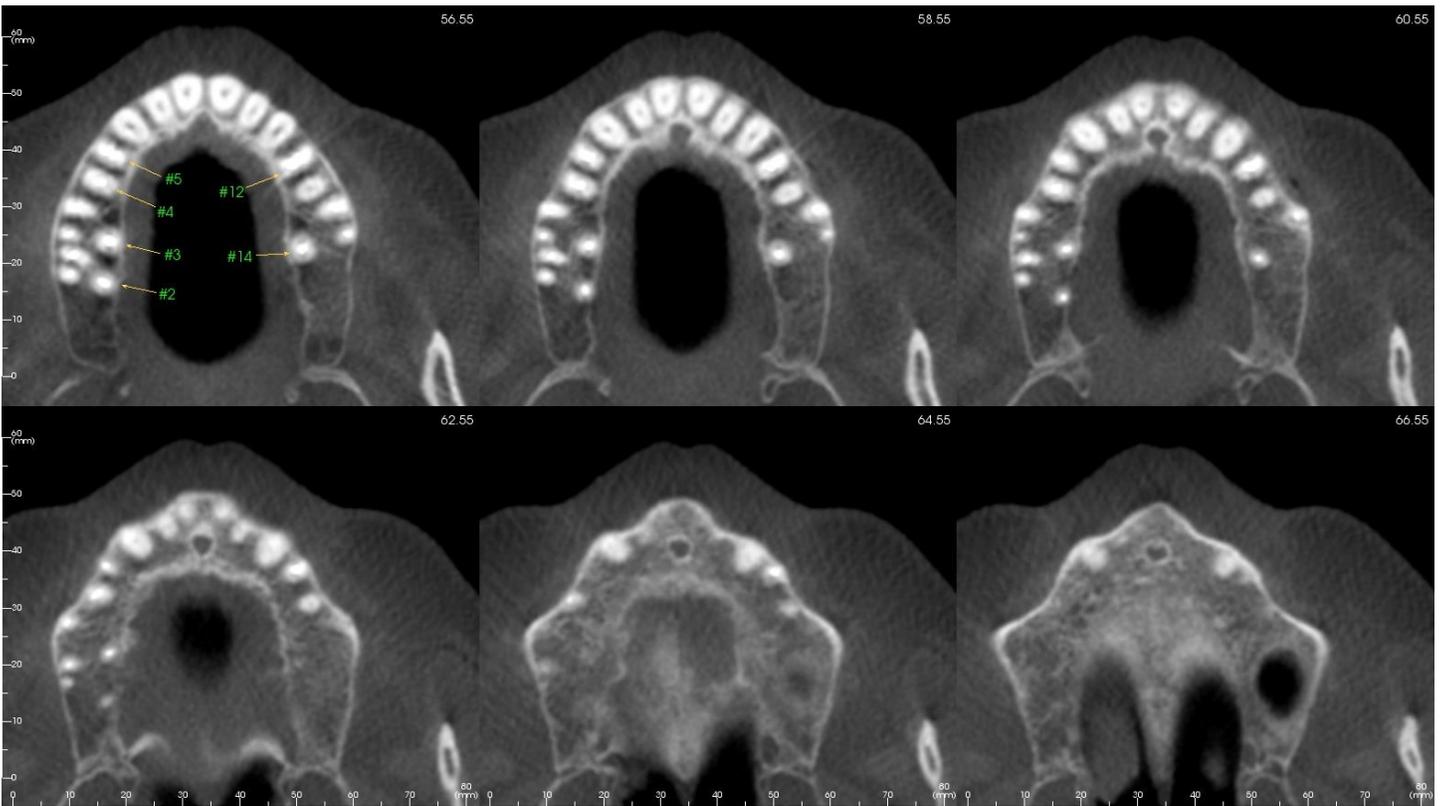
Root canal treatment: Teeth #2, 3, 4, 5, 12, 14 root canal filling material appears dense and thorough. No sign of bone reaction or rarefaction is seen. Tooth #18 root canal filling appears dense and thorough. There appears to be slight thickening of the periodontal ligament space near the apex of the tooth and hypodensity in the interradicular space.

Figure 2 - Maxillary dentition, axial view. Root canal treatment teeth #2, 3, 4, 5, 12, 14. Dense and thorough fills. Normal surrounding bone.

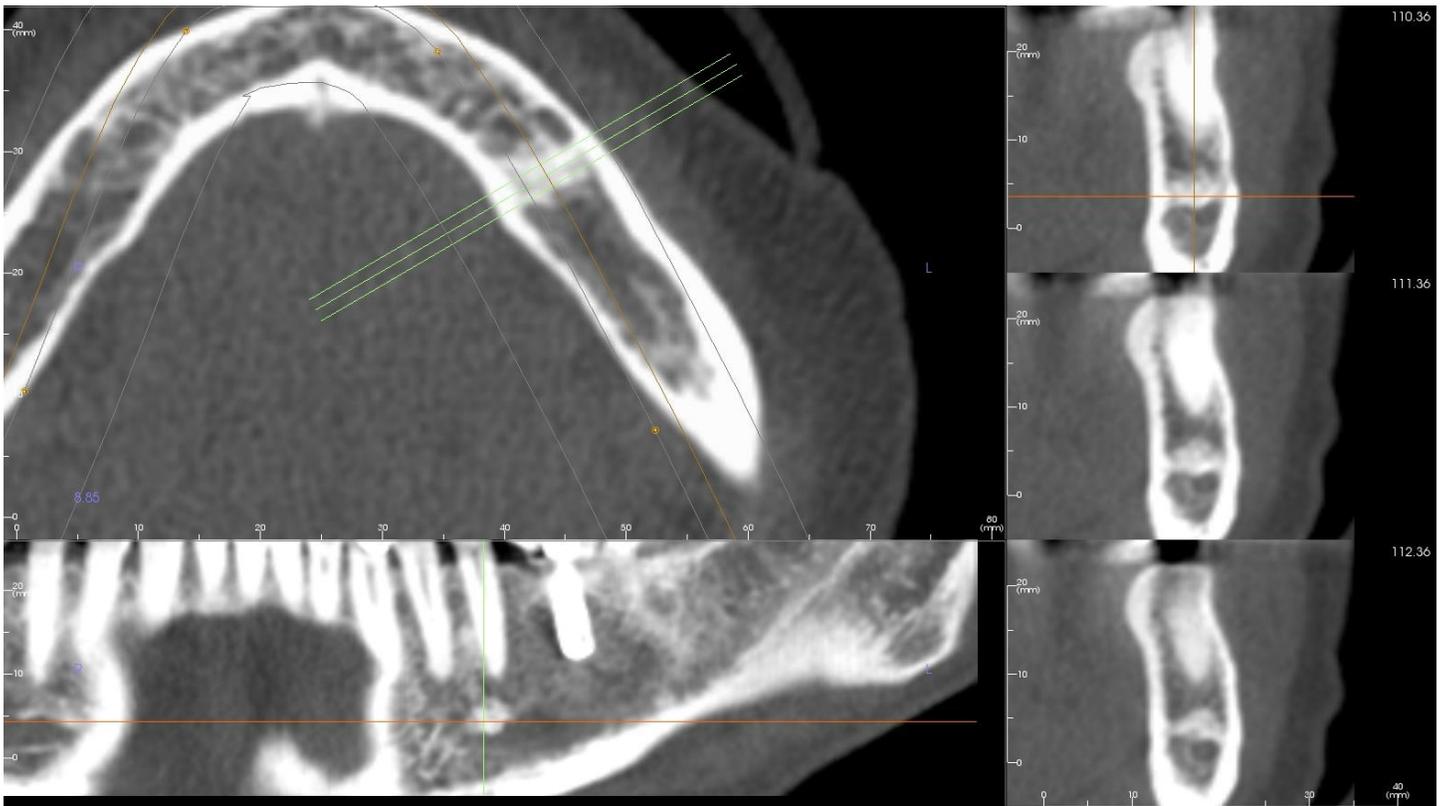
A hyperdense area of trabeculation apical to tooth #20 is noted, consistent with a dense bone island.

Figure 3 - Dense Bone Island

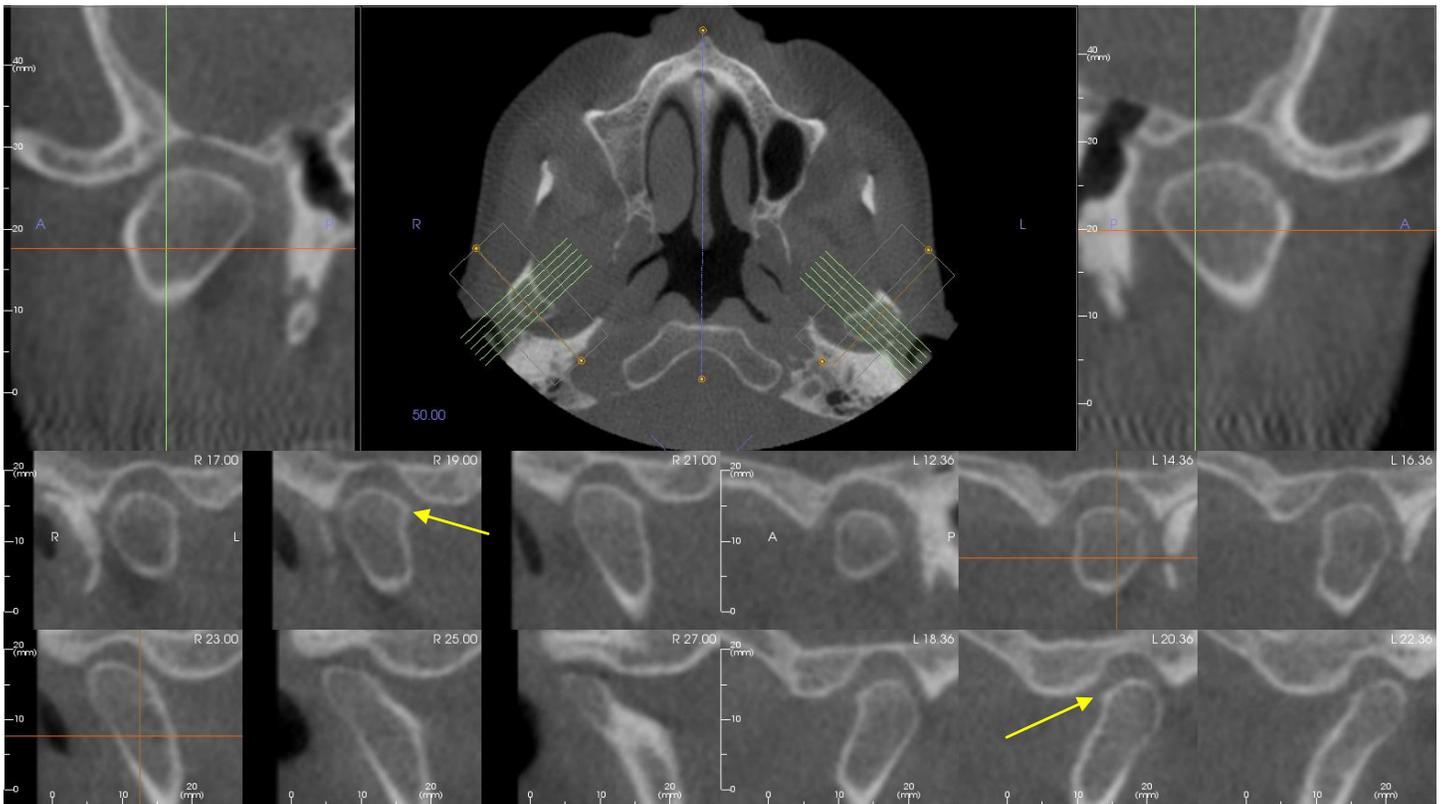
Condyles and fossae bilaterally show regular, uniform, corticated borders. Very slight hypodense protrusion on anterior border of both condyles suggestive of small osteophyte formation.

Figure 4 - TMJ. Largely unremarkable. Suggestive of small osteophytes (yellow arrows).

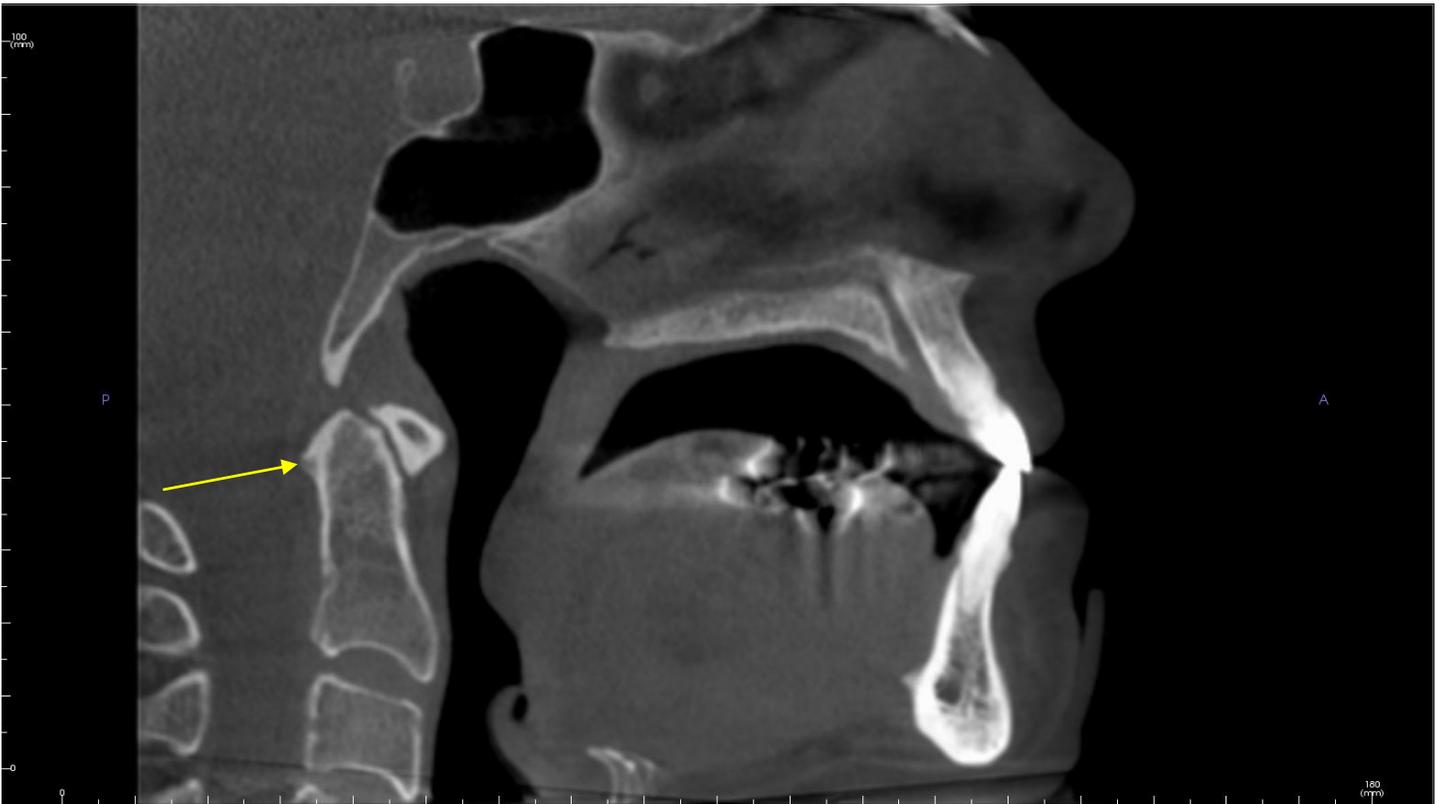
The cervical spine is normal in appearance with osteophyte formation on the posterior surface of the superior border of the dens.

Figure 5 – Sagittal. Osteophyte formation on dens (yellow arrow).

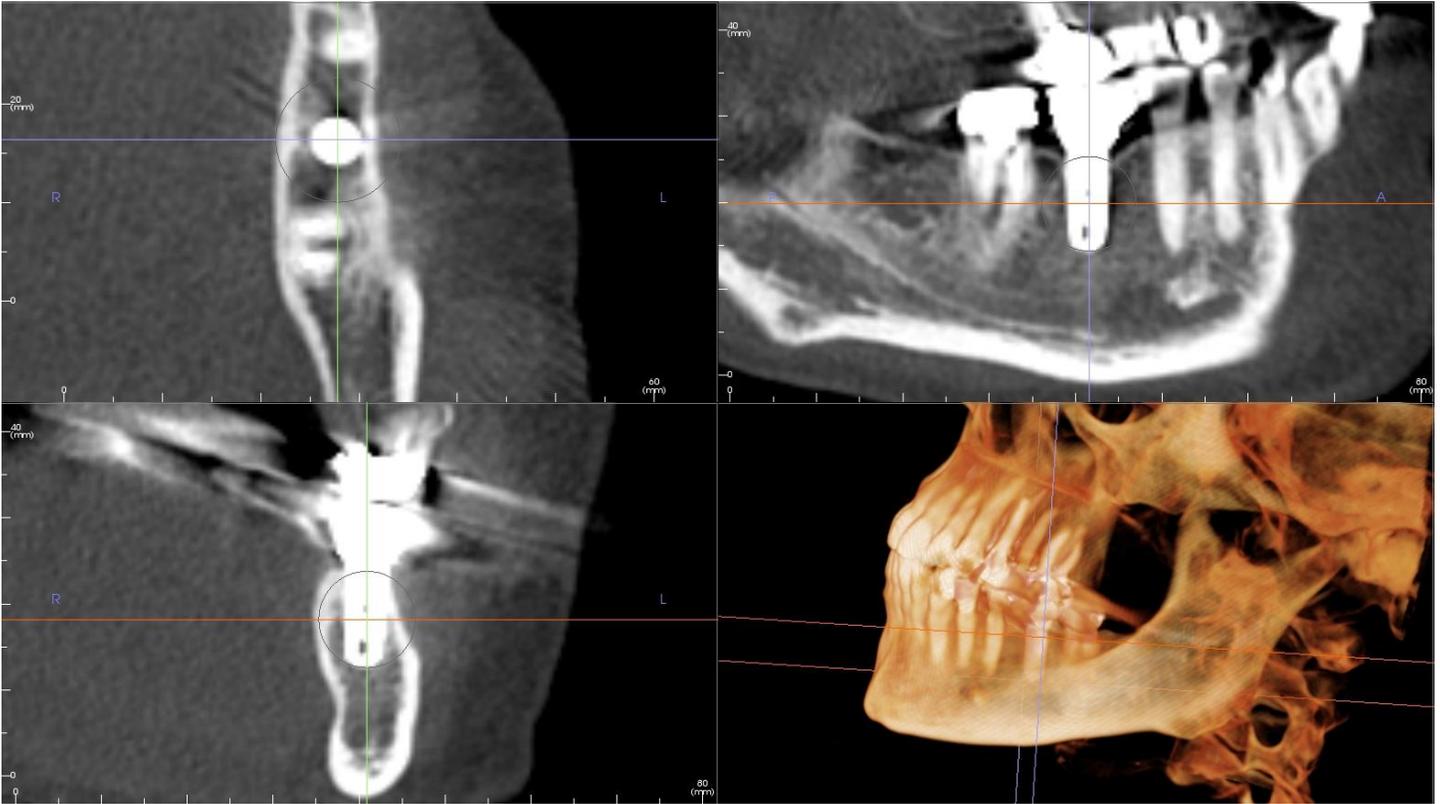
Dental Implants: Teeth #19 and 30. Good approximation of bone to implant surface. Bone level appears to be within 1-1.5 mm of the implant margin.

Figure 6 - Implant #19

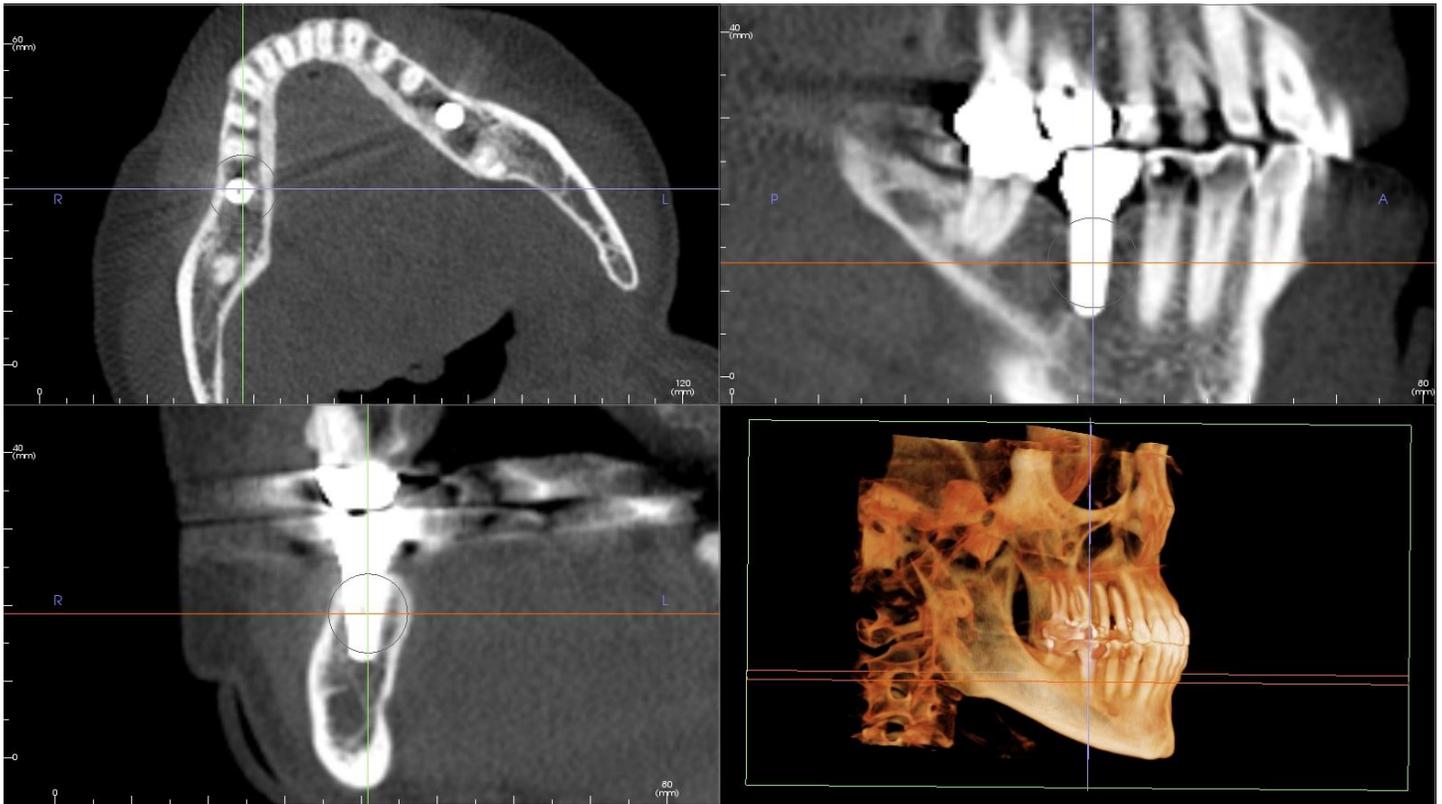
Figure 7 - Implant #30

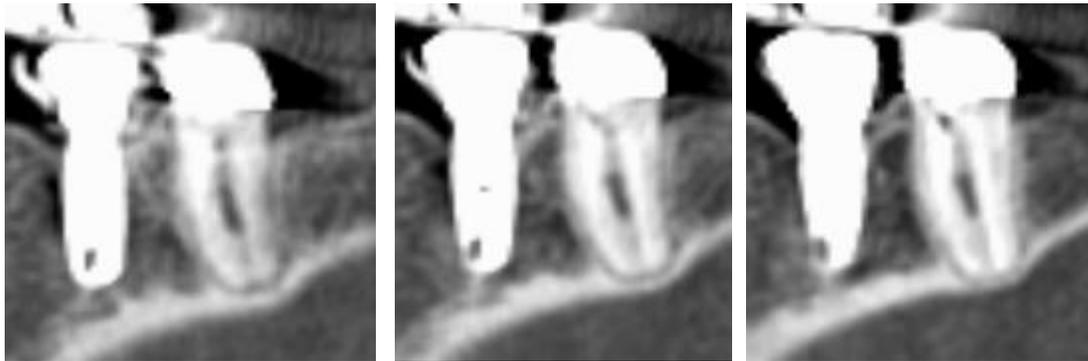
Figure 8 – Tooth #18, slightly widened PDL space and hypodense interradicular space.

1. Dense, thorough root canal fills. Slightly widened PDL space apical of #18 and interradicular radiolucency. Recommend periapical imaging and percussion testing.
2. Normal level of bone surrounding implants, with no evidence of infection or failure.
3. Dense bone island apical to tooth #20.
4. Osteophyte formation on dens of 2nd cervical vertebra.
5. Normal-appearing TMJs with evidence of small osteophyte formation.

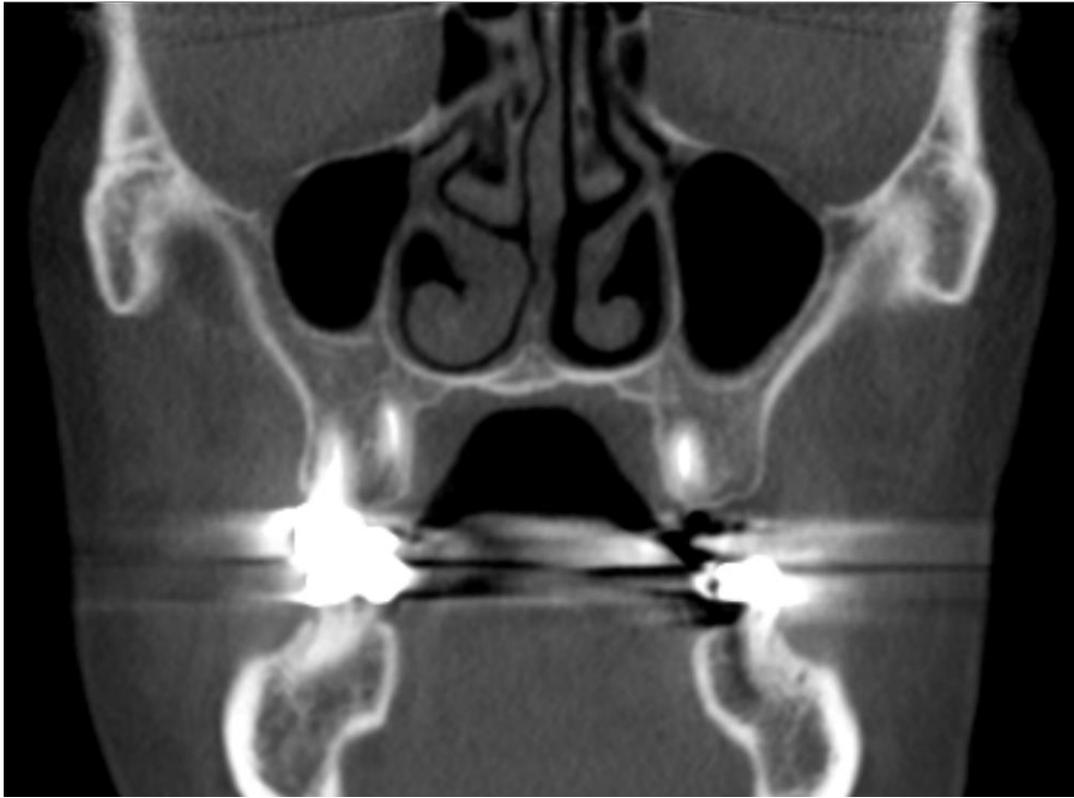
There is no evidence of mucosal thickening or air-fluid level in the sinuses. The maxillary, sphenoid and the portion of the ethmoidal sinuses and mastoid air cells that are visualized in this dataset are clear and aerated. Bilateral ostiomeatal units are patent with no evidence of previous surgery.

Figure 9 - Coronal, Clear maxillary, ethmoid sinuses. Patent ostiomeatal complexes.
